Expanded Site Inspection
Final Report

Pullman Factory
Chicago, Illinois
ILD 981 959 208

November 29, 1994

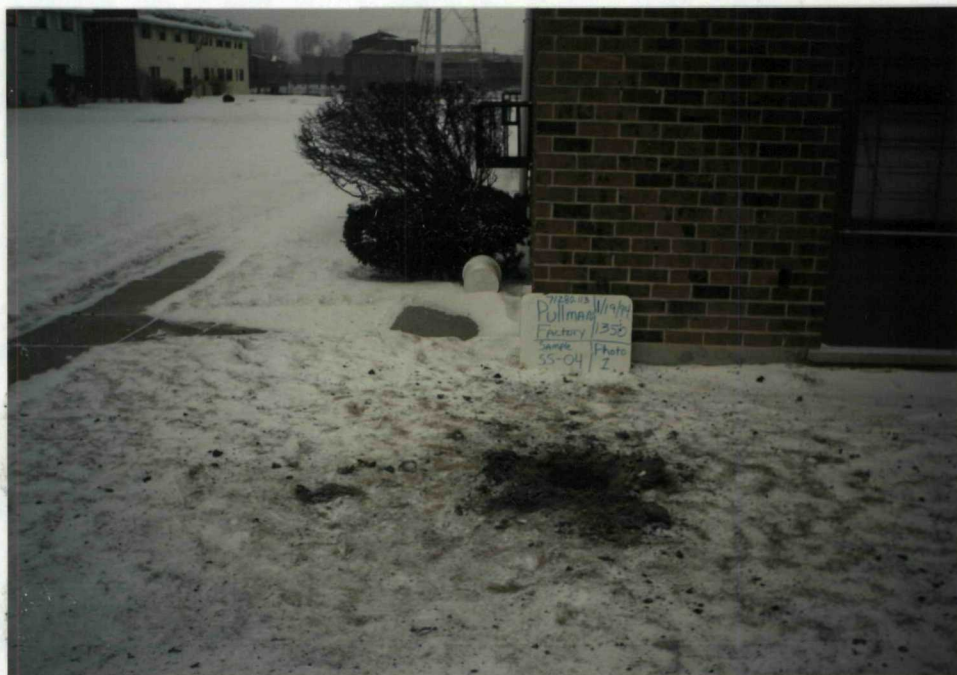
Description: Closeup of sample location
SS04, on Eden Green Cooperative prop-
erty, at the southwest corner of the
Jerry Poore Community Building.

Of the key samples that document the observed release, samples SS04 and SS05 were collected from Eden Green Cooperative property in the southwestern section of the site; both samples contained barium at concentrations meeting observed release criteria. Samples SS06, SS11, SS13, and SS14 were collected from onsite single family residential properties; these samples showed observed releases of bis(2-ethylhexyl)phthalate, lead, silver, or thallium. Sample SS16 was collected from a residential property just outside the southern site boundary; it showed an observed release of barium. Sample SS17 was collected just outside the southeastern corner of the site; it showed observed releases of arsenic and vanadium. Sample SS21 was collected from the DuBois Public School in the southwestern section of the site; it showed observed releases of manganese, thallium, and cyanide. Sample SS23 was collected from Golden Gate Park in the northern portion of the site; it contained xylene at a concentration above background that meets observed release criteria. All samples were collected from depths of less than two feet.

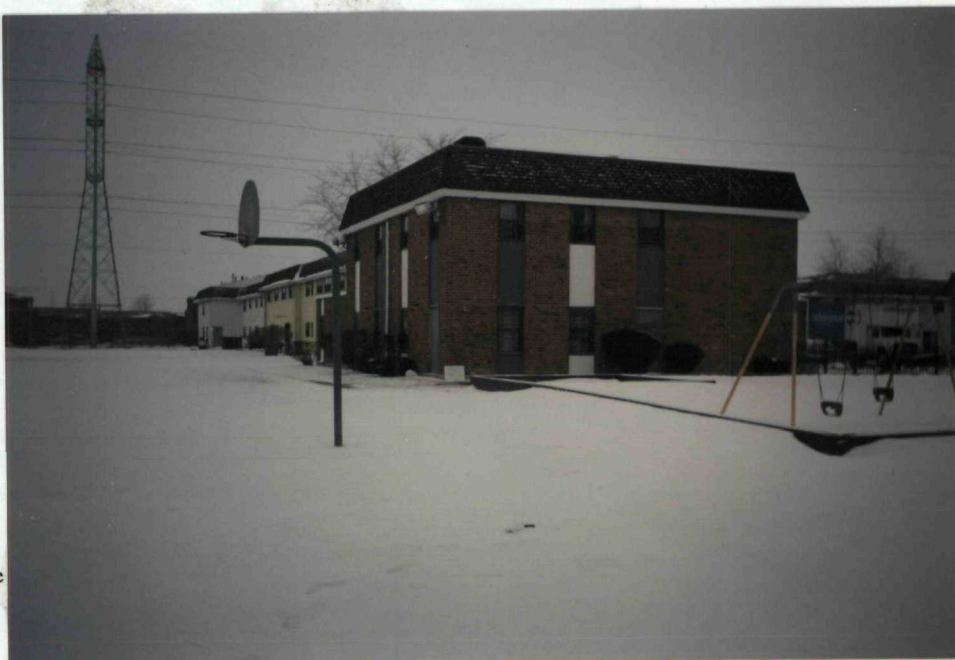
Description: Perspective view of sample
location SS04, on Eden Green Cooperative
property. Playground and basketball
court in foreground; community building
in background.

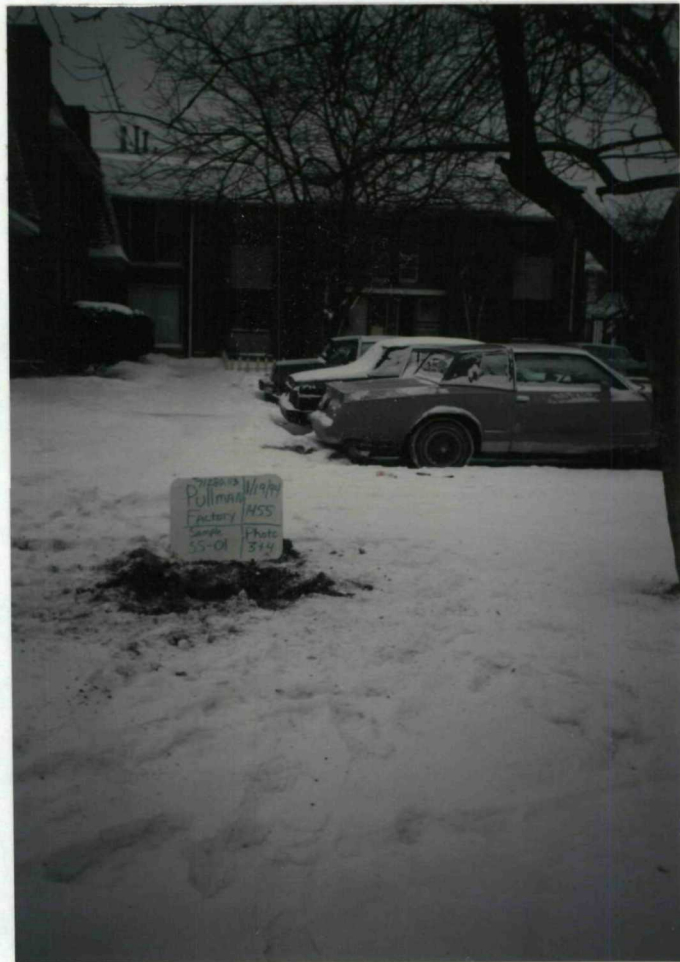
Description: Closeup of offsite
background sample location SS01,
on Eden Green Cooperative property,
near southwest corner of 132nd Street
and Indiana Ave.

A background sample, SS01, was collected west of the site near the southwest corner of 132nd Street and Indiana Avenue, on Eden Green Cooperative property. This location was selected as representative of offsite soil conditions in the area.

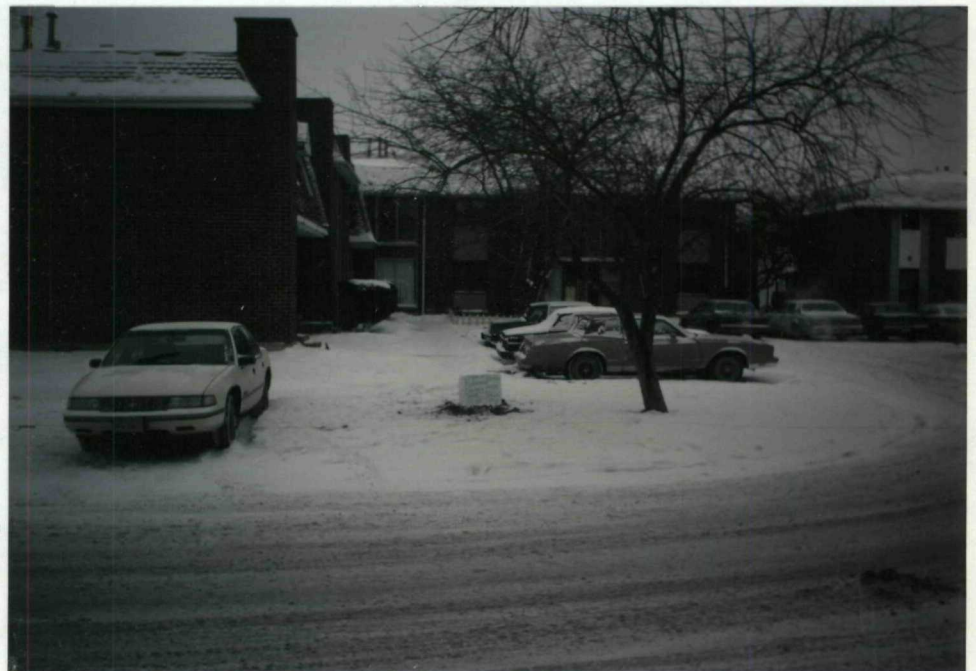
Description: Perspective view of offsite
background sample location SS01, on
Eden Green Cooperative property.
Apartment buildings in background.

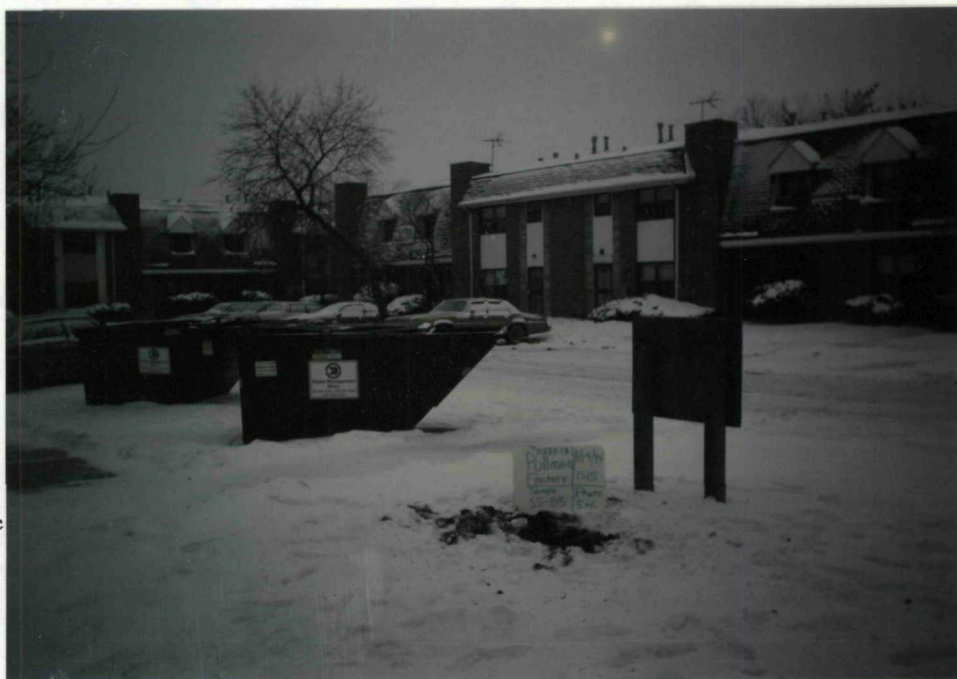
Description: Closeup of sample location SS05, on Eden Green Cooperative property, east of 132nd Street and Indiana Ave., behind an Eden Green Cooperative sign, near apartment buildings.

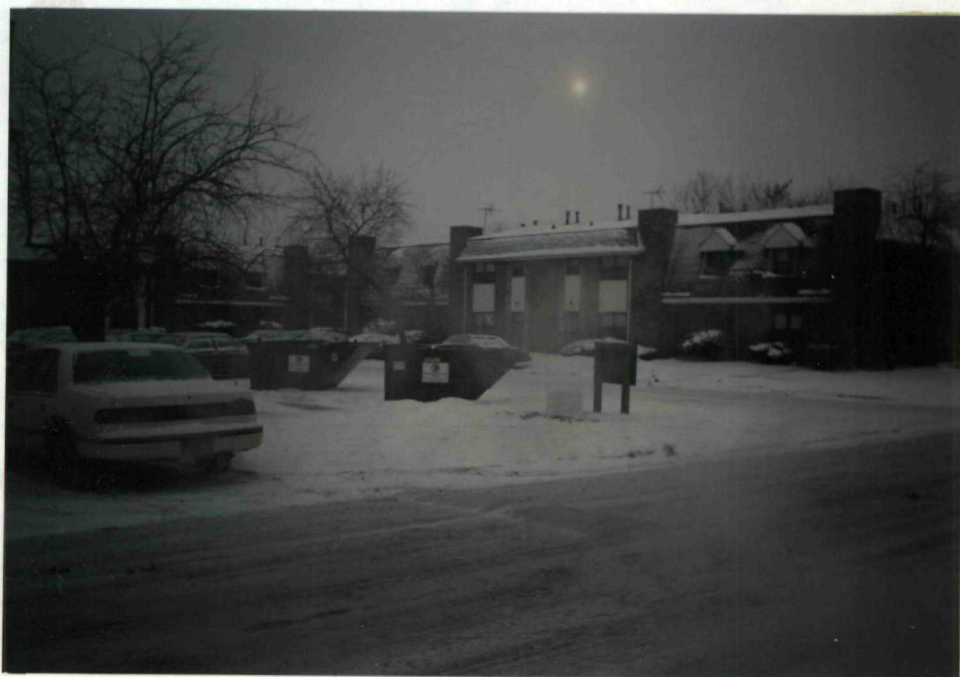
Description: Perspective view of sample location SS05, on Eden Green Cooperative property. Apartment buildings are in the background.

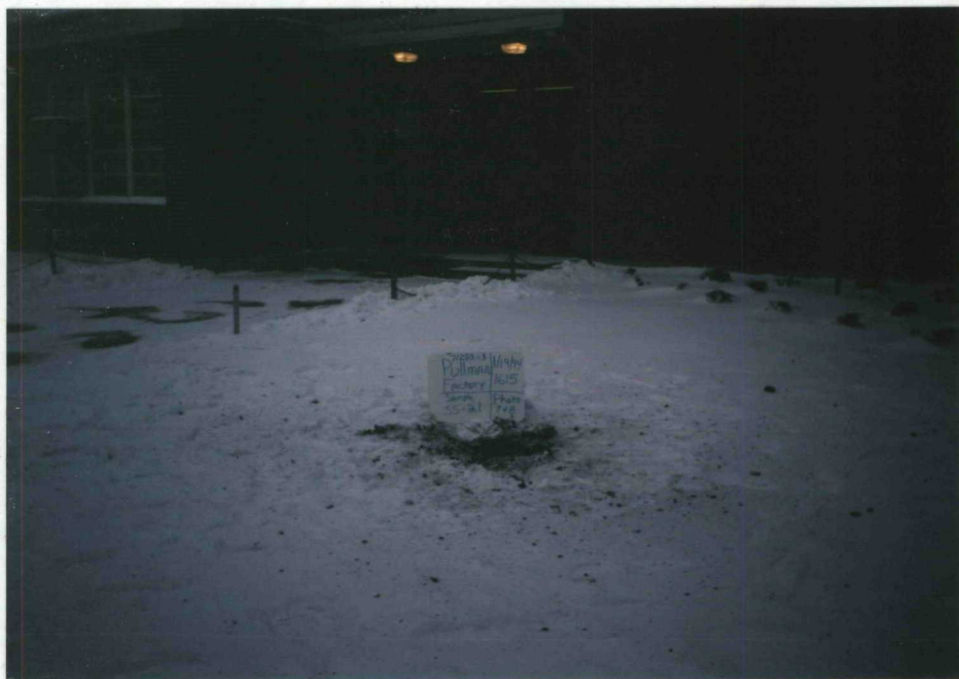
Description: Closeup of sample location
SS21, on front lawn of W.E.B. DuBois
Public School, near school entrance.

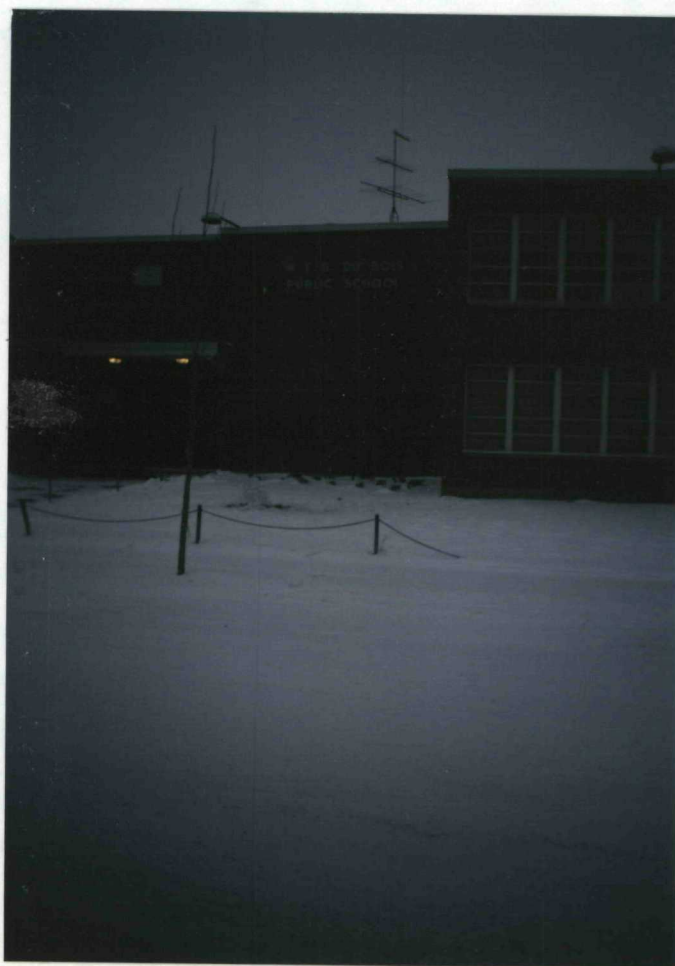
Description: Perspective view of sample
location SS21, on front lawn of W.E.B.
DuBois Public School. School is
in the background.

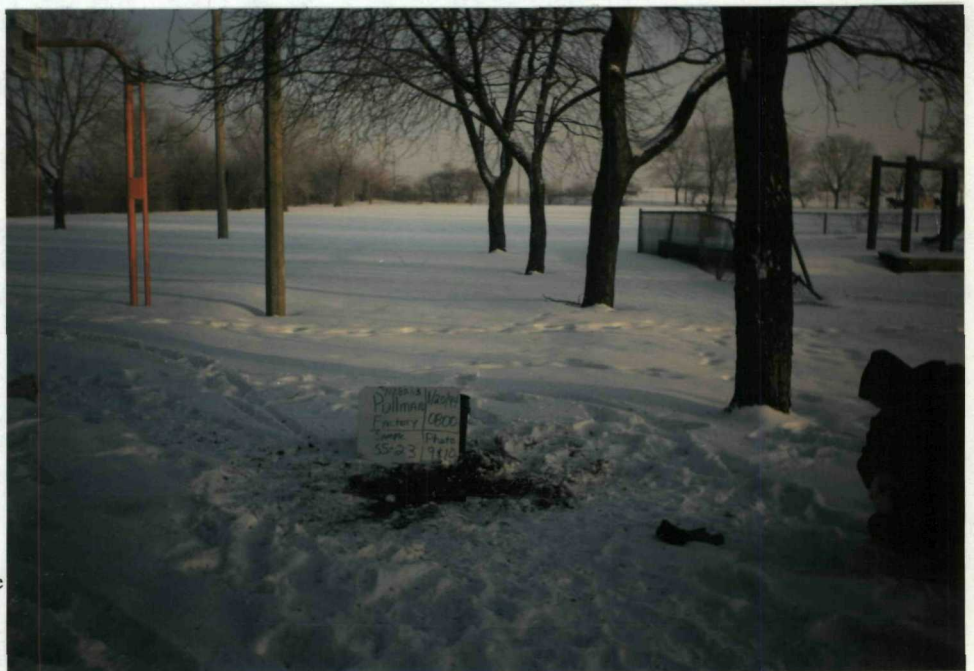
Description: Perspective view of sample
location SS23, in southwestern section
of Golden Gate Park, between a
playground and basketball court.

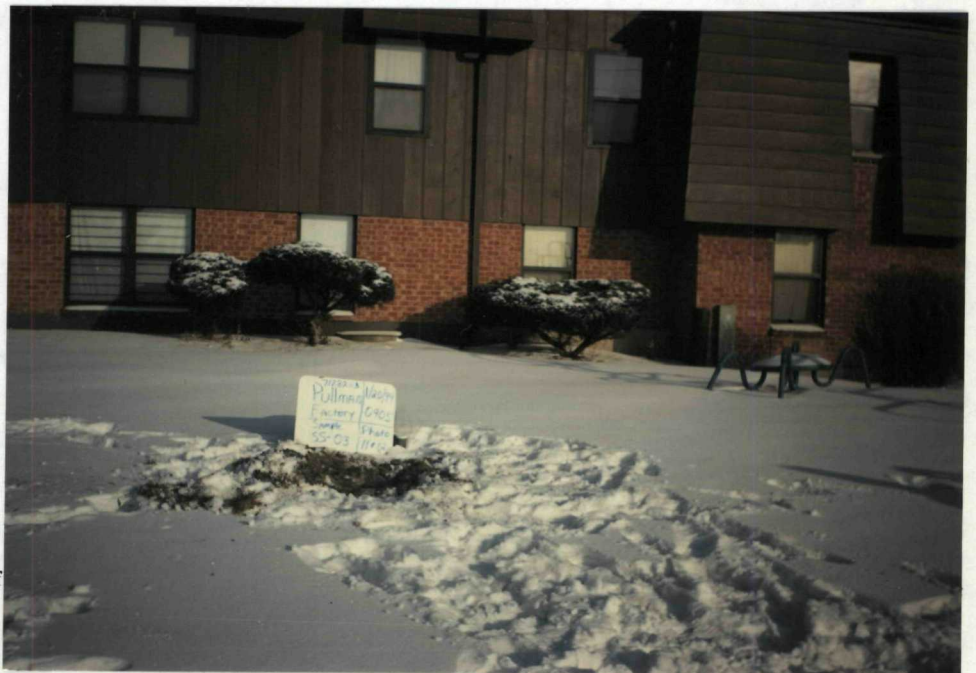
Description: Perspective view of sample
location SS03, in southwestern section of
Concordia Park Apartments property.
Small play area and an apartment
building are in the background.

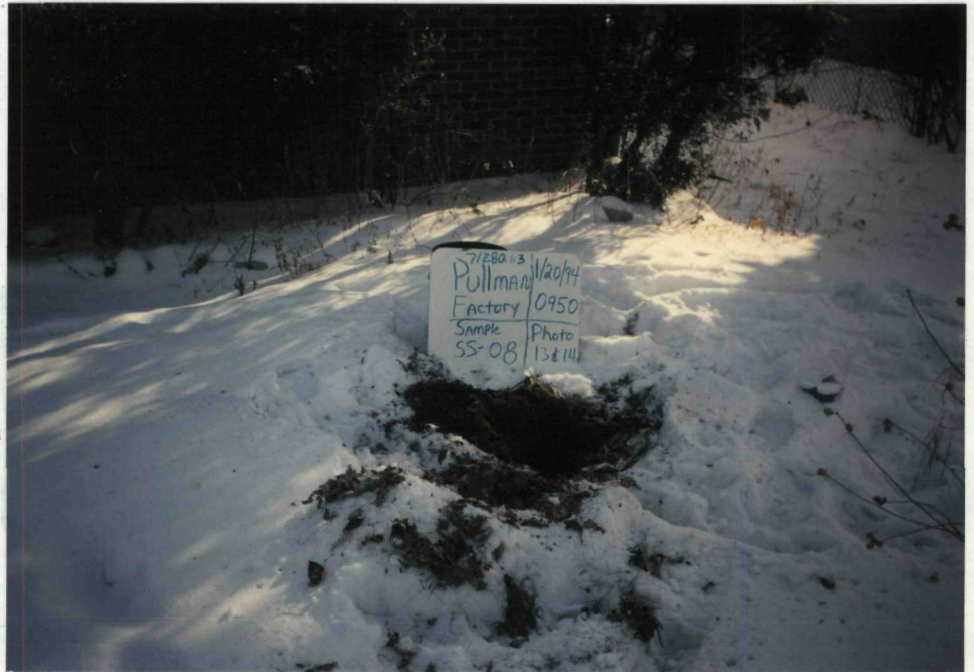
Description: Closeup of sample location
SS08, on front lawn of residence along
Eberhart Ave, in northeastern section
of the site.

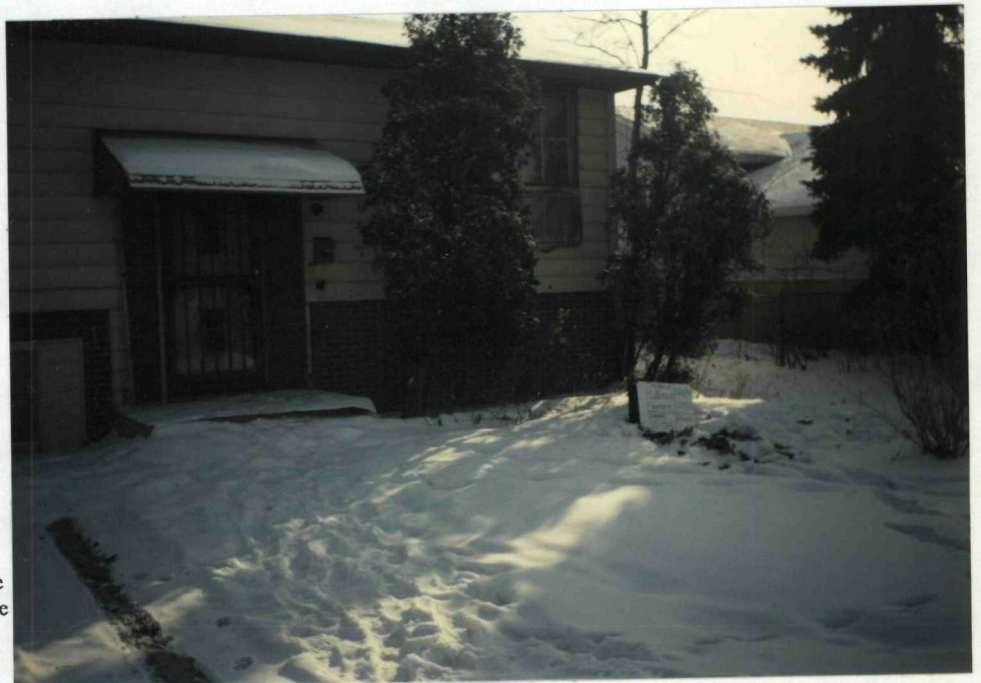
Description: Perspective view of sample
location SS08, on front lawn of residence
along Eberhart Ave. Residence is
in the background.

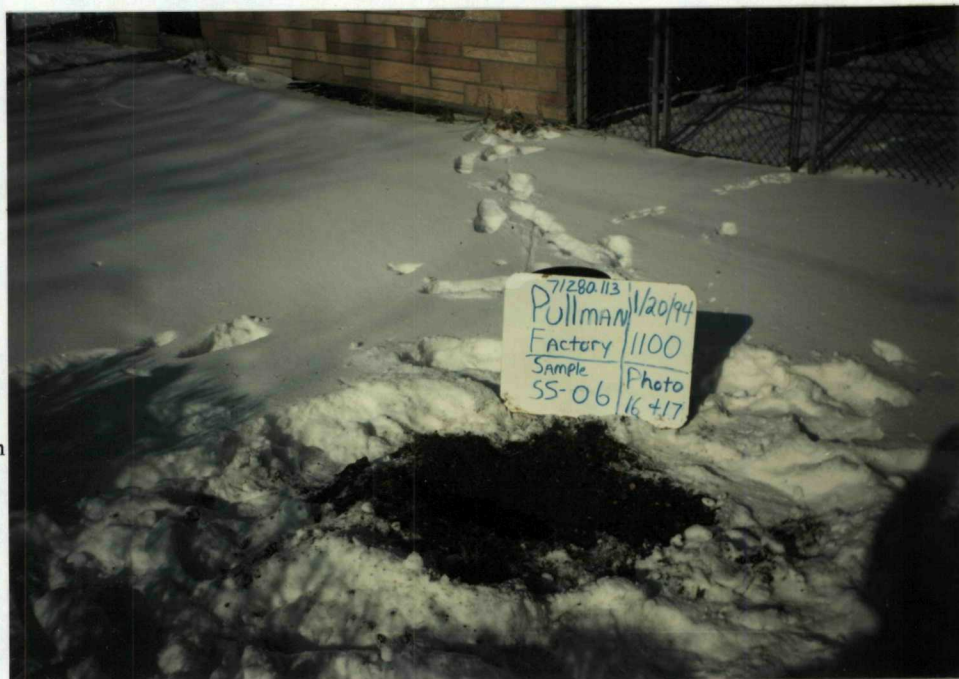
Description: Closeup of sample location
SS06, on front lawn of residence along
134th Street, in southwestern section
of the site. Photo numbers shown on
placard are incorrect.

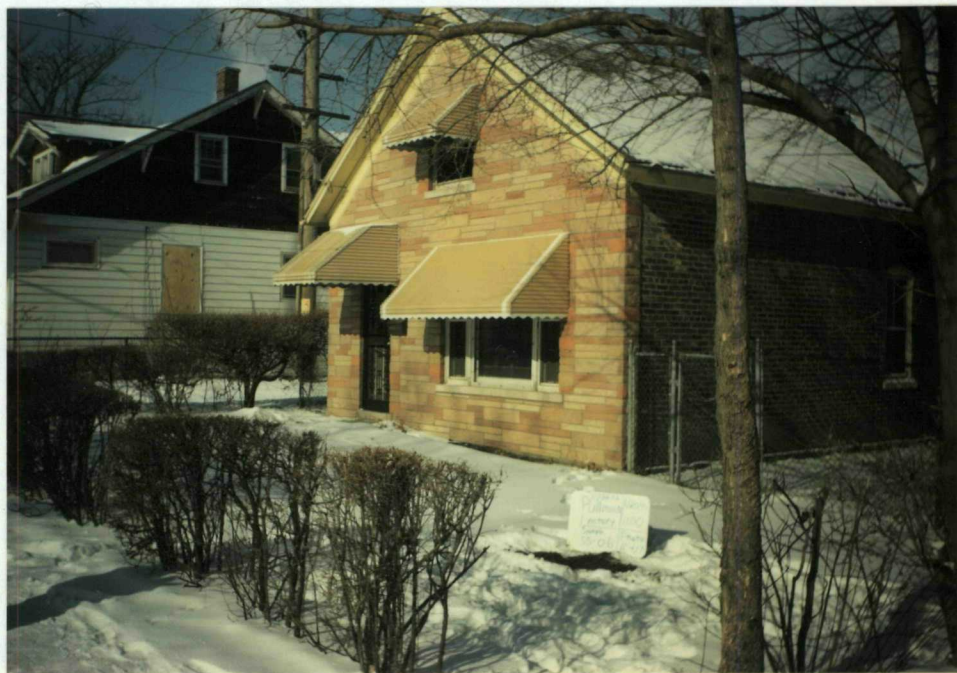
Description: Perspective view of sample
location SS06, on front lawn of residence
along 134th Street. Residence is in
the background.

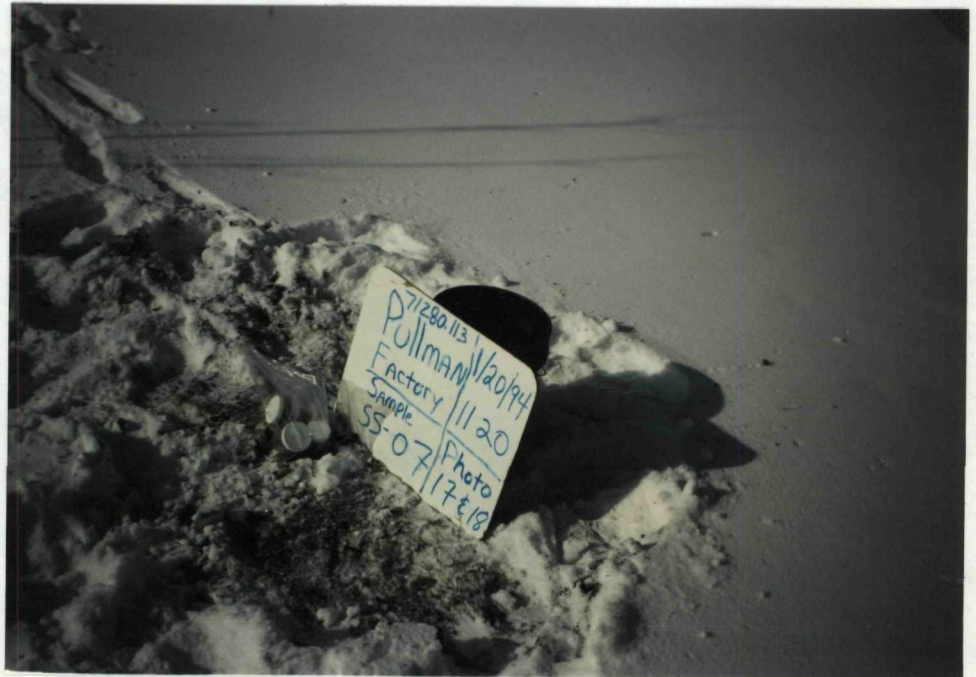
Description: Closeup of sample location
SS07, on front lawn of residence along
134th Street, in south-central portion
of the site.

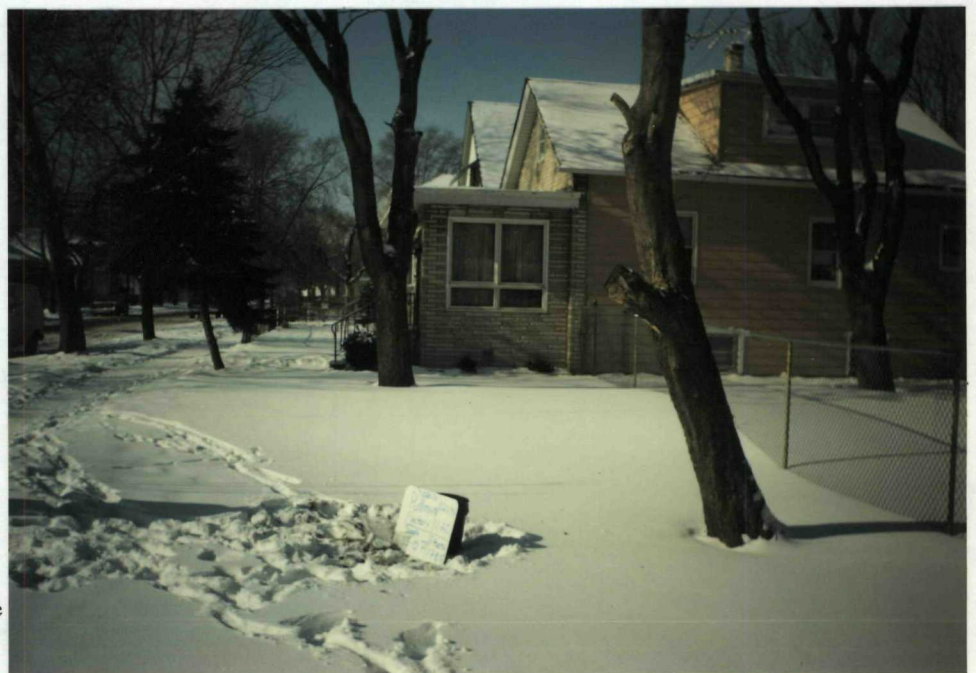
Description: Perspective view of sample
location SS07, on front lawn of residence
along 134th Street. Residence is in
the background.

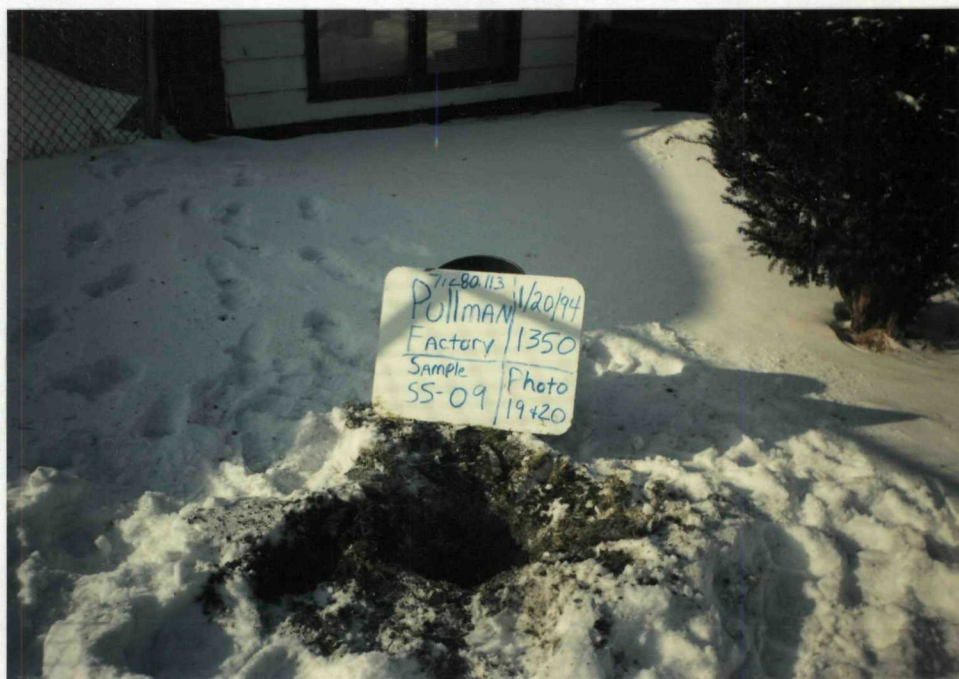
Description: Closeup of sample location
SS09, on front lawn of residence along
Forrestville Ave., in northeastern
section of the site.

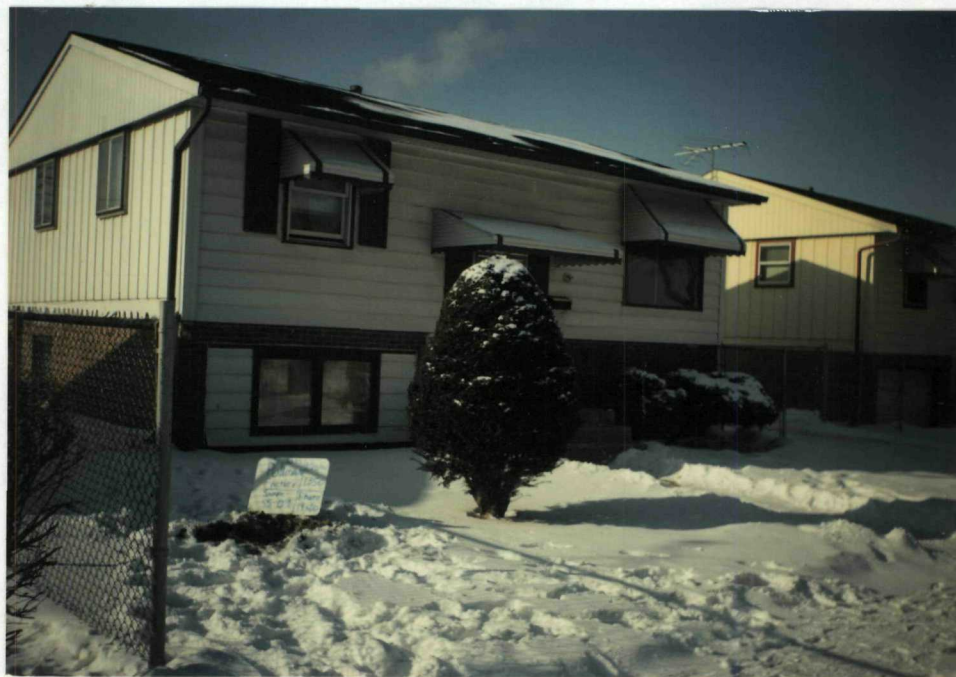
Description: Perspective view of sample
location SS09, on front lawn of residence
along Forrestville Ave. Residence is
in the background.

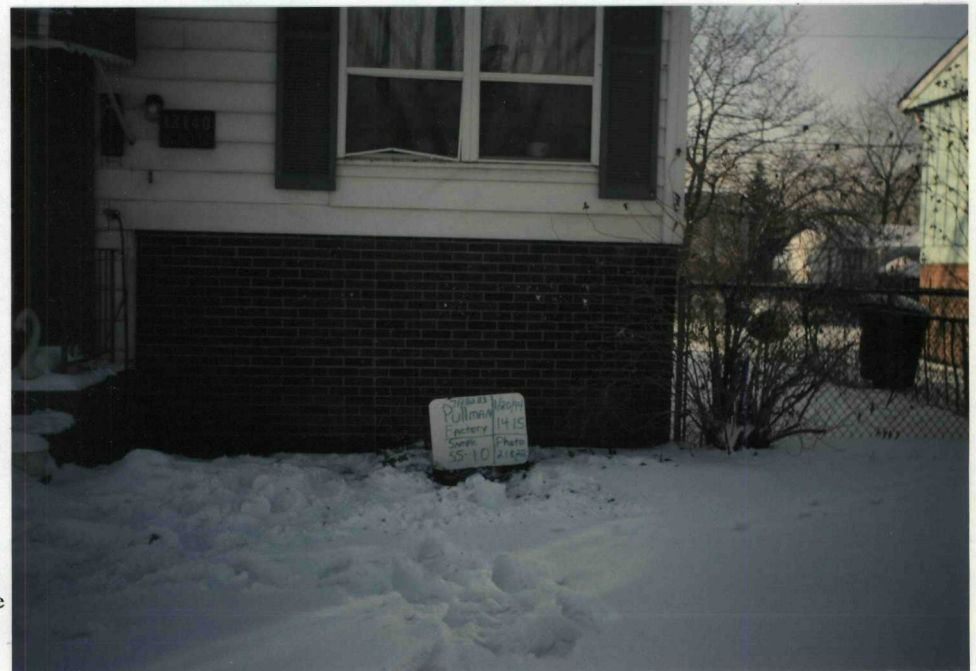
Description: Perspective view of sample
location SS10, on front lawn of residence
along St. Lawrence Ave. Residence
is in the background.

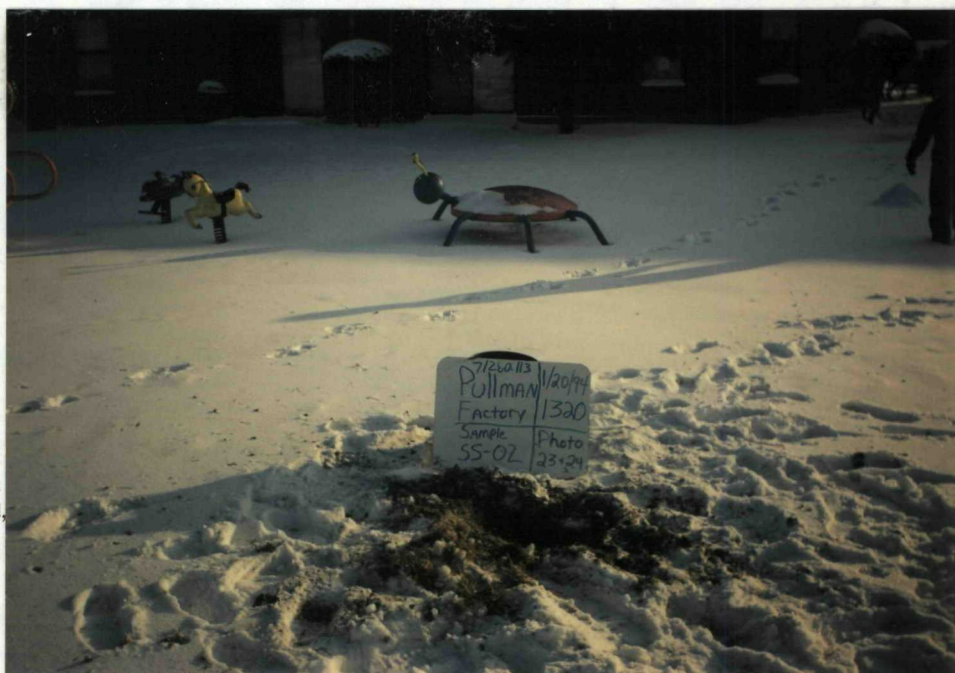
Description: Closeup of sample location
SS02, on northeastern section of Concordia
Park Apartments property, in an open field,
near a small play area and apartments.
Time shown on placard is incorrect.

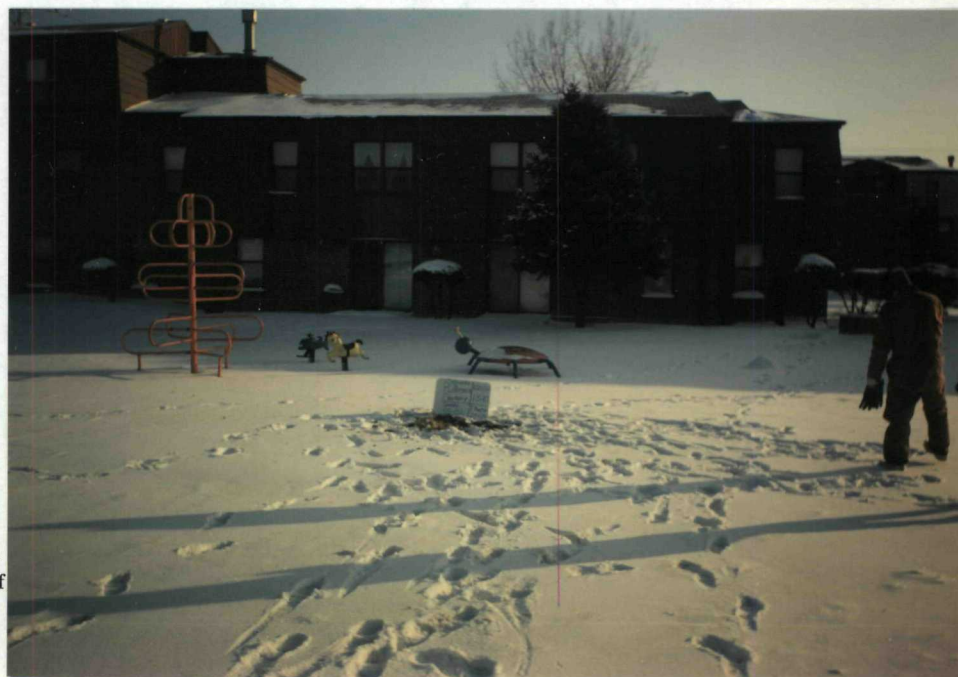
Description: Perspective view of sample
location SS02, on northeastern section of
Concordia Park Apartments property.
Small play area and an apartment
building are in the background.

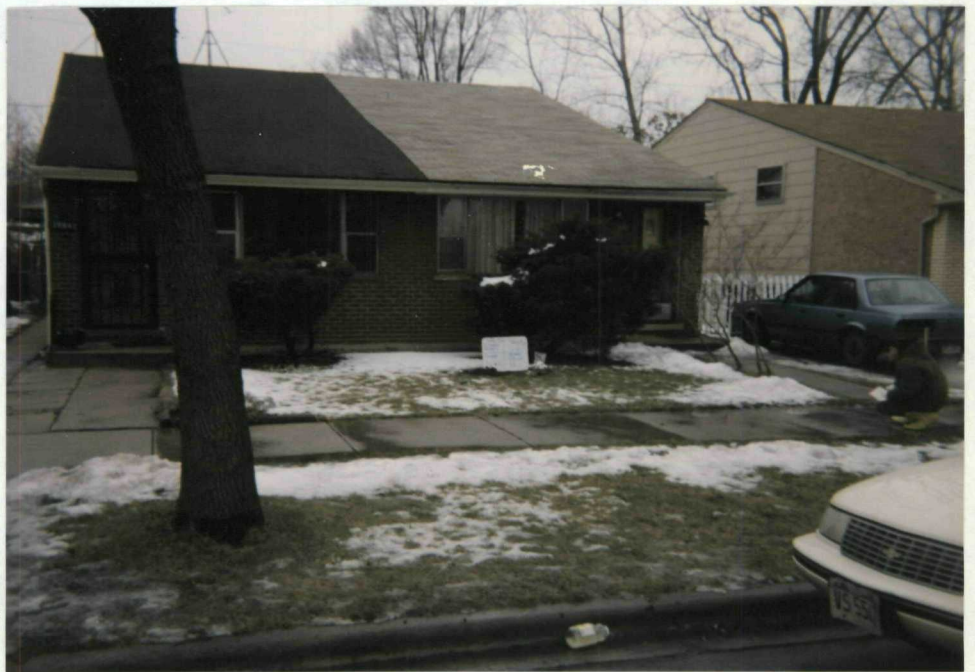
Description: Perspective view of sample
location SS12, on front lawn of residence
along Vernon Ave. Residence is
in the background.

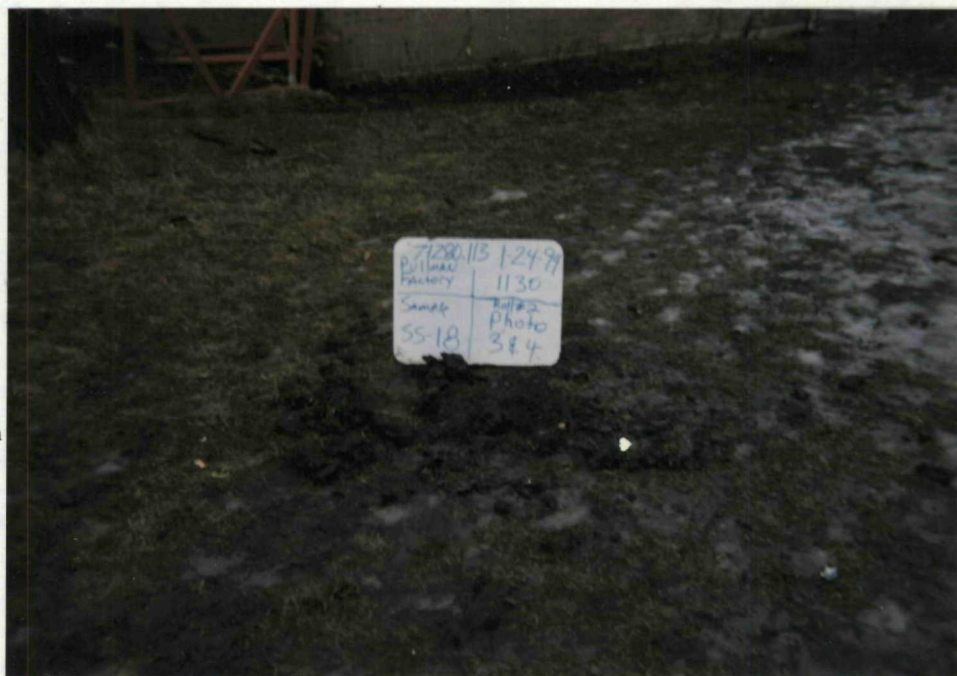
Description: Closeup of sample location
SS18, on Altgeld Gardens property east
of the site, at southeastern corner of
St. Lawrence Ave. and 131st Street,
near an apartment building.

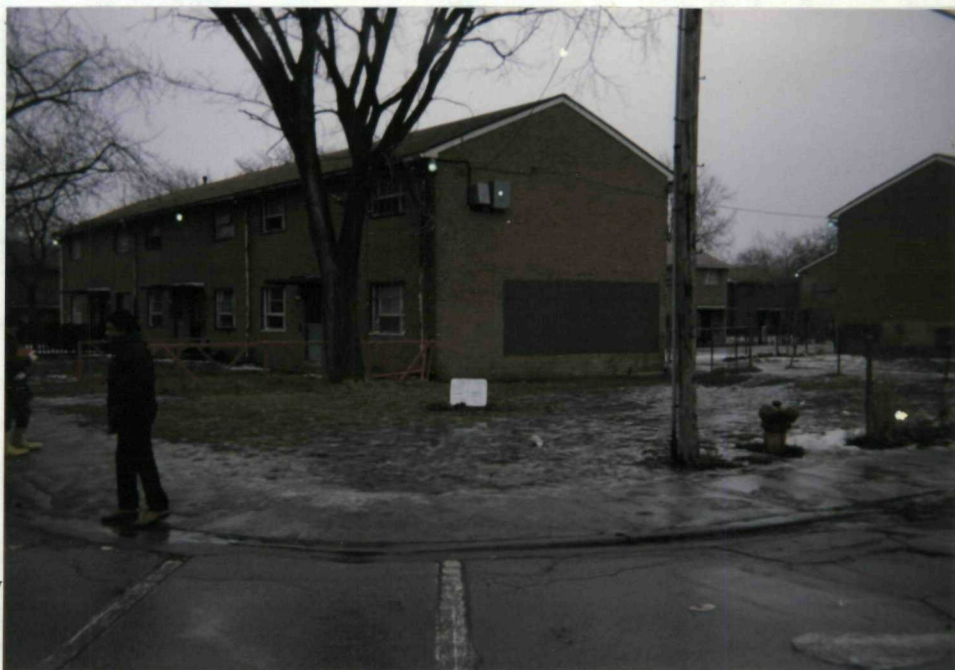
Description: Perspective view of sample
location SS18, on Altgeld Gardens property
east of the site, at southeastern corner of
St. Lawrence Ave. and 131st Street.
Apartment building is in the background.

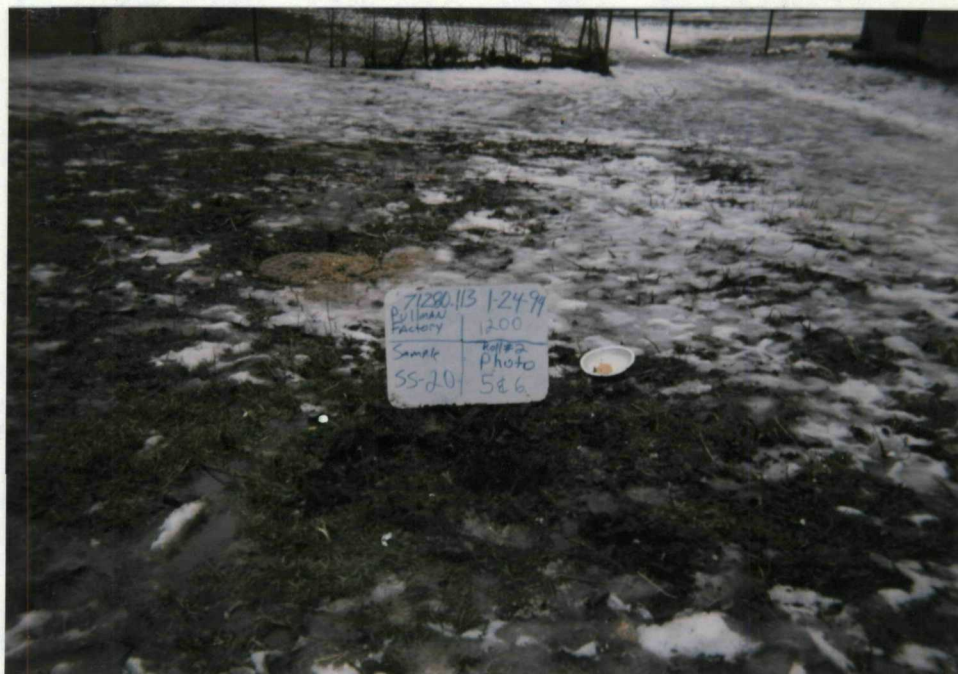
Description: Closeup of sample location
SS20, on Altgeld Gardens property east
of the site, at the south end of a court-
yard surrounded by apartment buildings.

Pesticide results and key sample SS20 were eliminated from consideration as documentation of an observed release because they were not attributable to the Pullman Factory site.

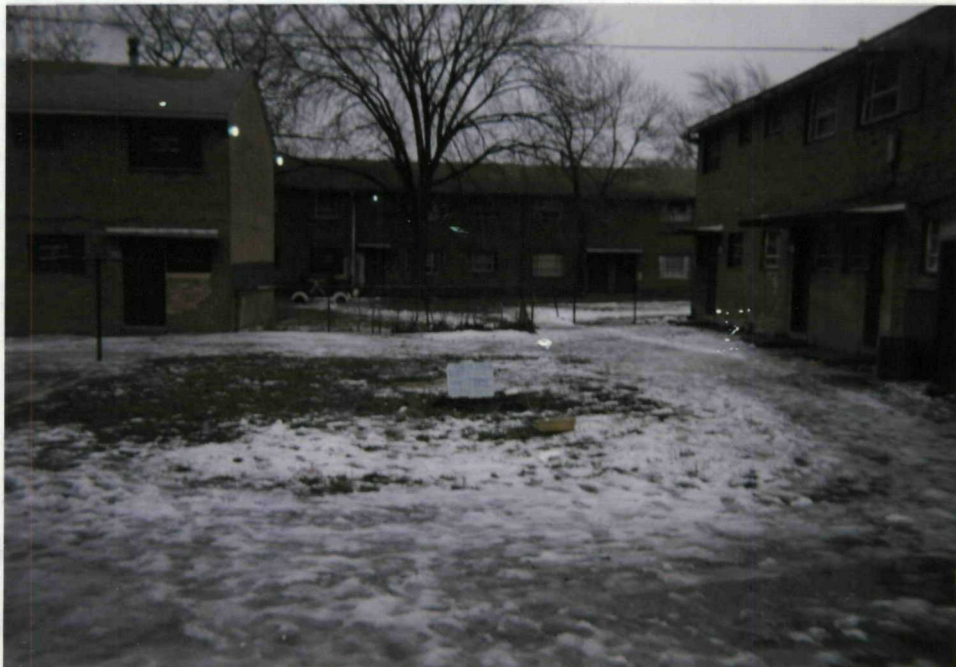
Description: Perspective view of sample
location SS20, on Altgeld Gardens pro-
perty east of the site, at the south end
of a courtyard surrounded by apartment
buildings.

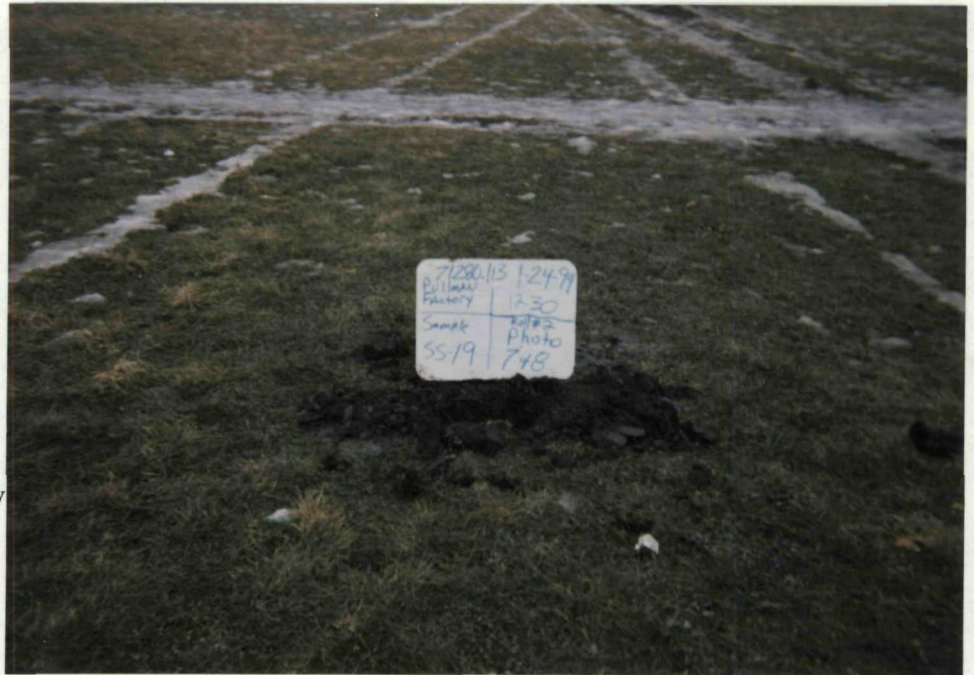
Description: Closeup of sample location SS19, on Altgeld Gardens property east of the site, in an open field surrounded by apartment buildings and a play ground, east of the intersection of 132nd Street and St. Lawrence Ave.

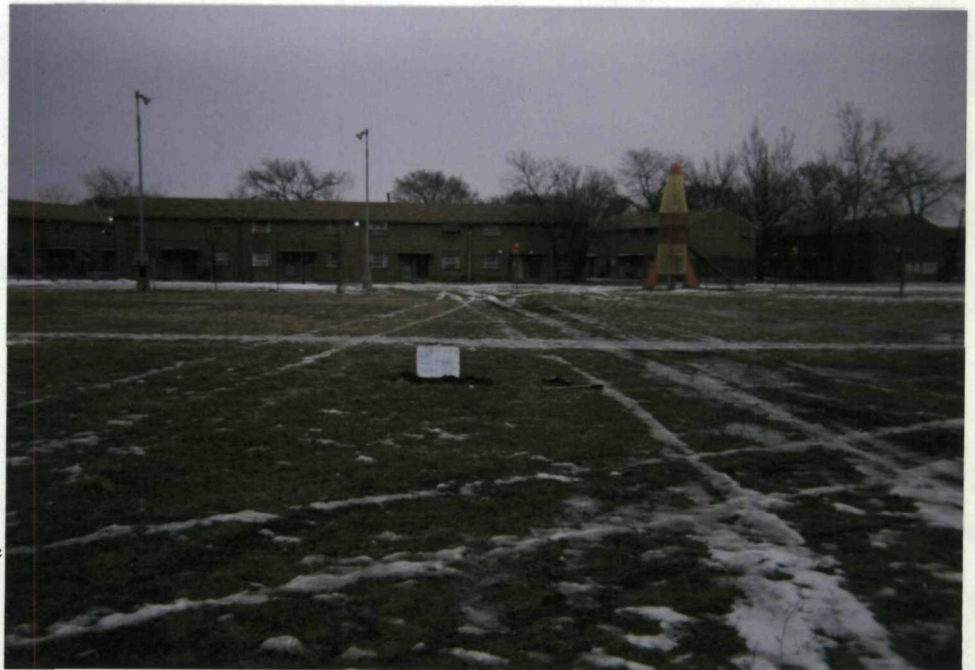
Description: Perspective view of sample location SS19, on Altgeld Gardens property east of the site, in an open field. Playground and apartment buildings are in the background.

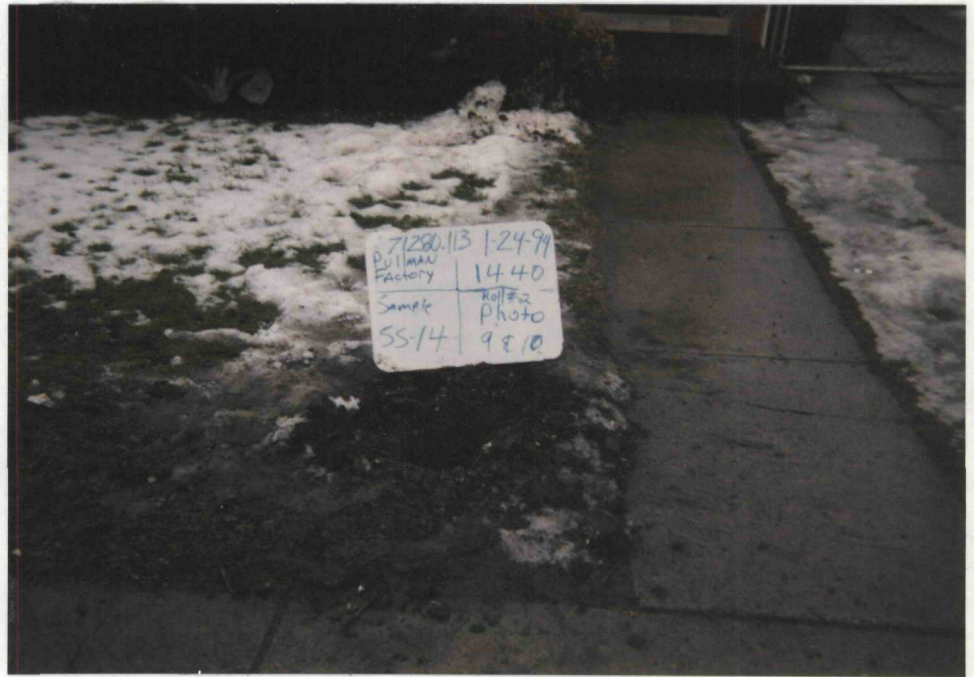
Description: Closeup of sample location
SS14, on front lawn of residence along
134th Street, in the southeastern
section of the site.

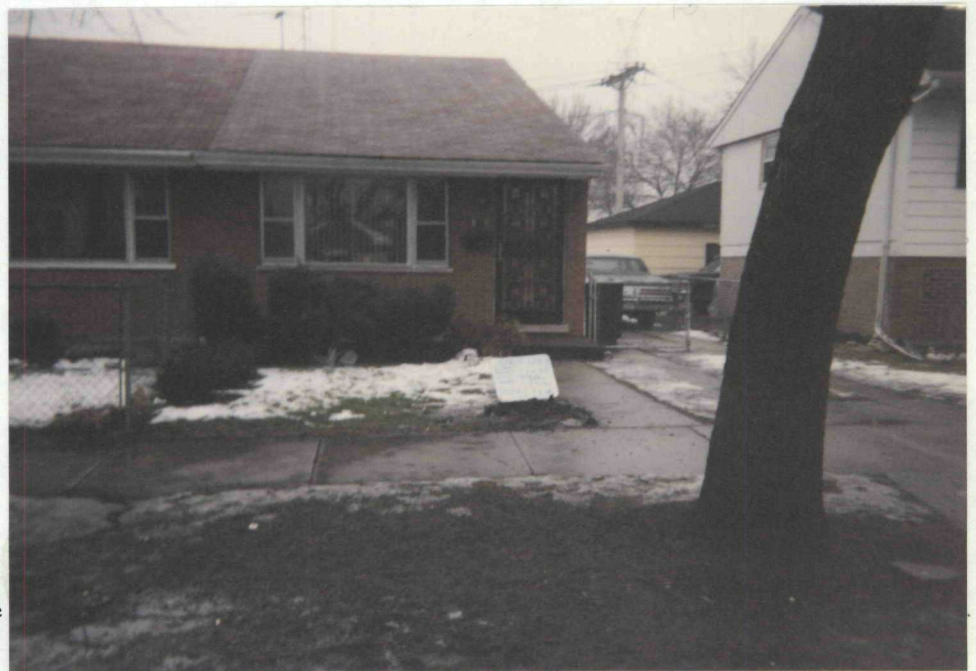
Description: Perspective view of sample
location SS14, on front lawn of residence
along 134th Street. Residence is in
the background.

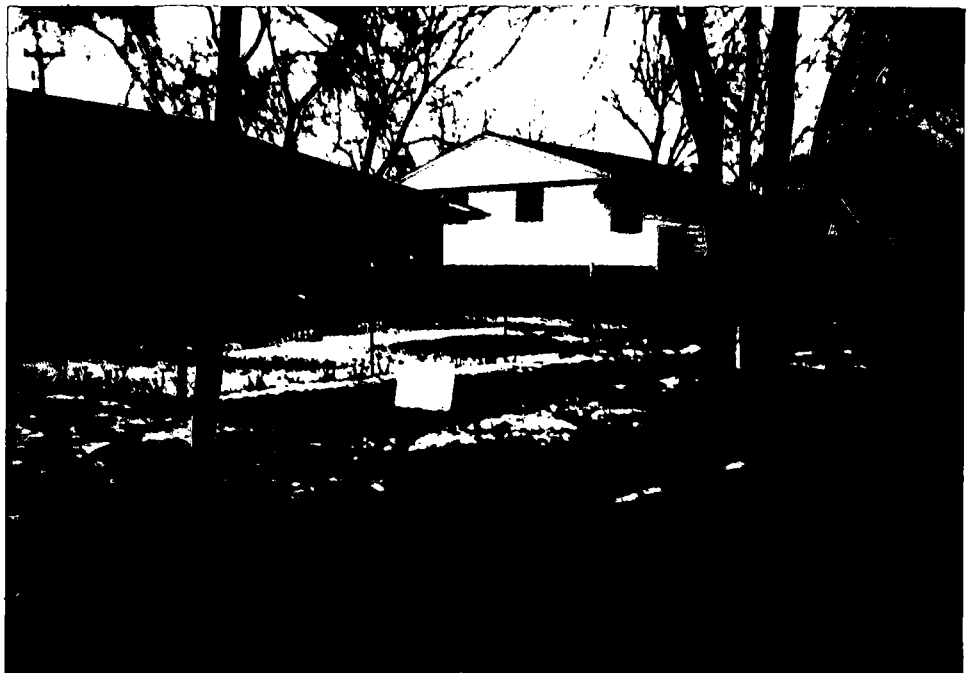
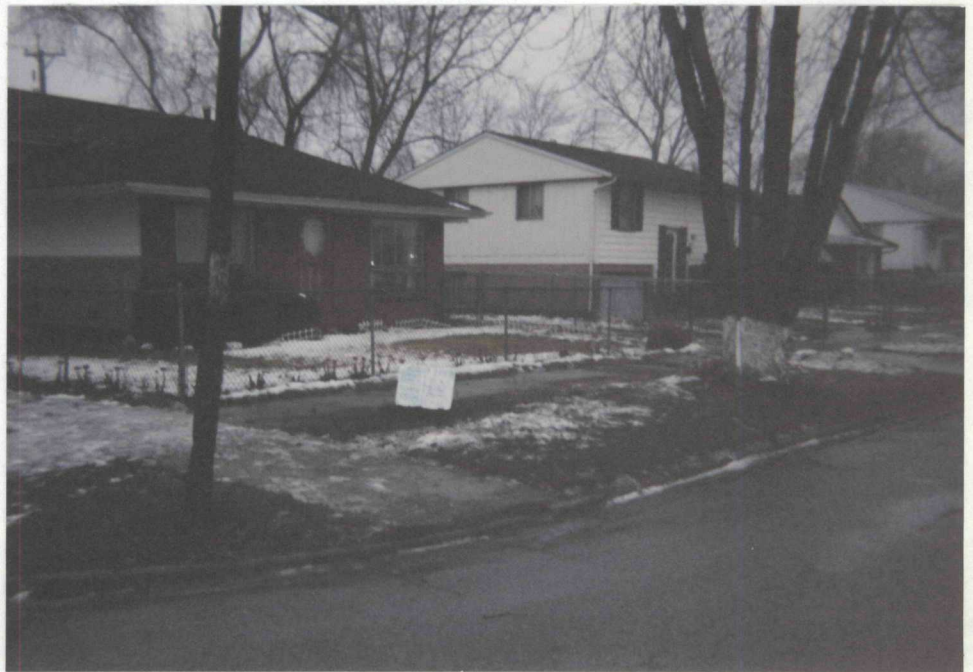
Description: Perspective view of sample
location SS15, on front lawn of residence
along St. Lawrence Ave. Residences
are in the background.
